Report to the Chairman, Committee on  
National Security, House of  
Representatives

DEFENSE  
INVENTORY

Action Needed to  
Avoid Inappropriate  
Sales of Surplus Parts

B-280096

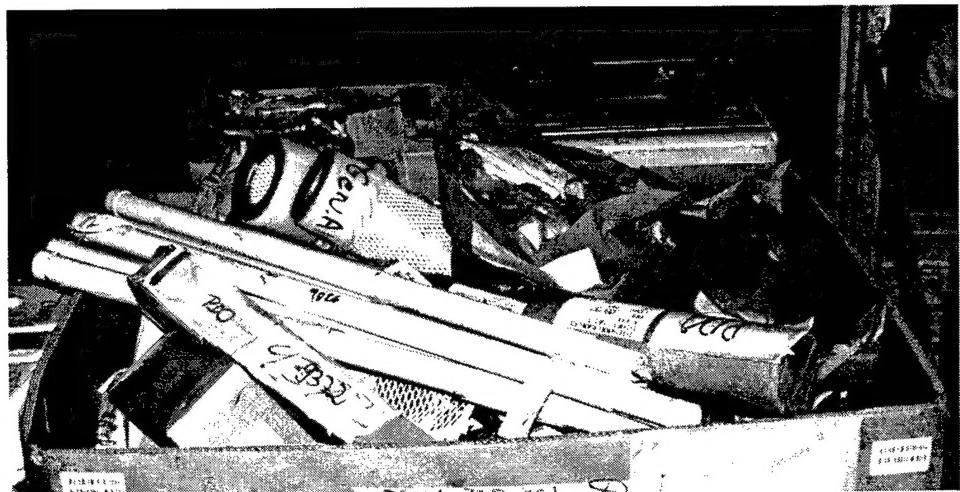
**Figure 2: Batch Lot Containing Military Technology Items**

DRMOS also inadvertently offered to sell some parts with military technology intact because DRMO personnel made errors in consolidating parts having military technology implications with parts not having these implications. This occurred when several single items were accumulated together and offered for sale as a batch lot. Although the batch lot was recorded as having no military technology implications, some individual parts in the lot contained protected military technology. For example, a batch lot of 42 weapons parts available for sale to the public at the Kaiserslautern DRMO contained 7 parts with military technology that should have been destroyed (see fig. 2). DRMO personnel subsequently removed the military technology items from the batch lot. DRMO supervisors stated that action would be taken to educate personnel on the required content of batch lots and that supervisory checks of batch lot contents would be made periodically to ensure that no parts with military technology are included in future batch lots.

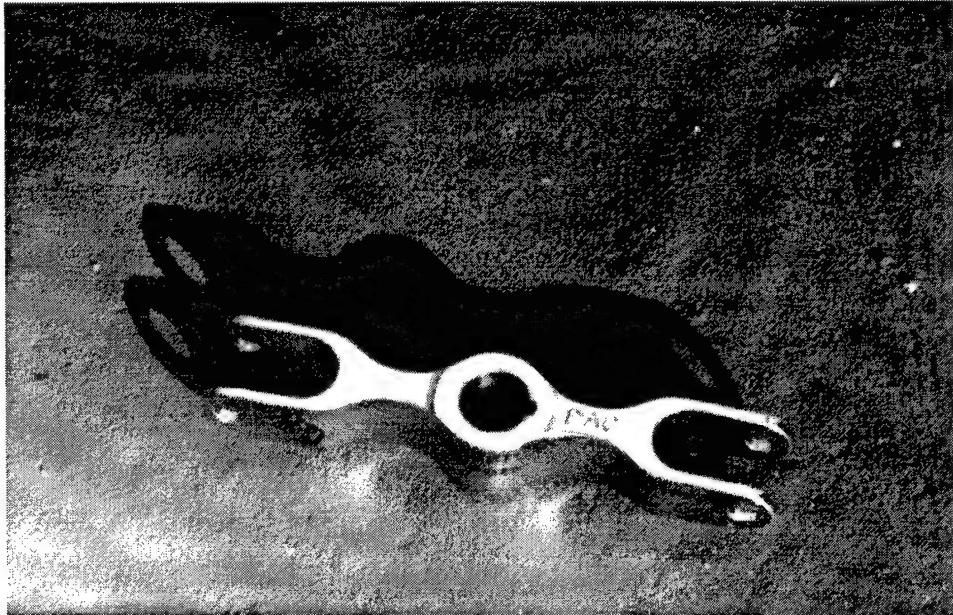
**Figure 4: Tail Rotor Control Assembly**

Also, in February 1998, the Kaiserslautern DRMO was offering for sale three tail rotor control assemblies used on the AH-1 Cobra helicopter (see fig. 4). If this part were to fail, the aircraft would spin uncontrollably and crash. The parts were not accompanied by required documentation stating it was safe to reuse them. DRMO officials said that they had not received any notification from the Army that this item had flight safety implications. Sales history information showed that this same part, described as being in severely worn condition, was sold in July 1996 by the DRMO in Columbus, Ohio, without any assurance that the part was safe to reuse.
